# Sometimes the Right Diagnosis Costs Less Than the Wrong Repair

Tracing a persistent dampness problem in a farm villa using targeted investigation,  
PQWT and thermal imaging

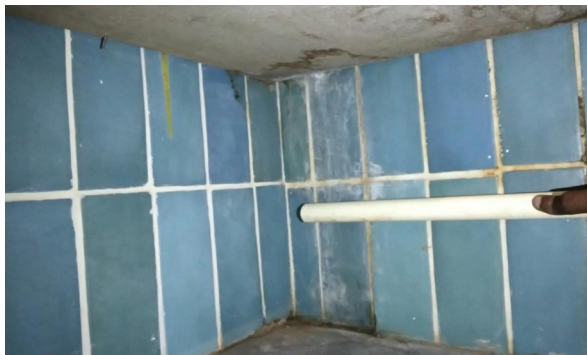
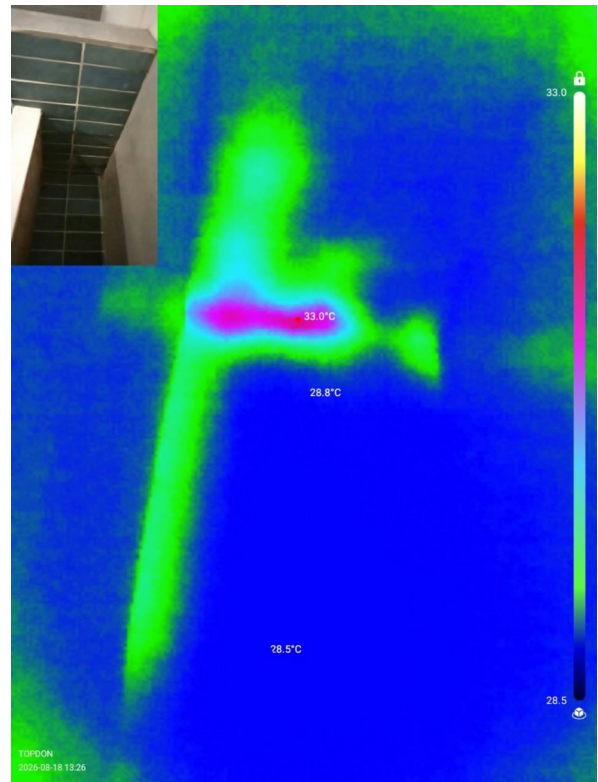
Site condition and thermal imaging used to investigate the moisture pathway.

The thermal images showed distinct temperature anomalies along localized wall and service-line zones. When these observations were correlated with the site layout and the PQWT investigation, the suspected source was narrowed to the water inlet pipe near the sink location.

This finding changed the repair strategy from broad treatment of the visibly affected walls to a focused intervention at the suspected water source.

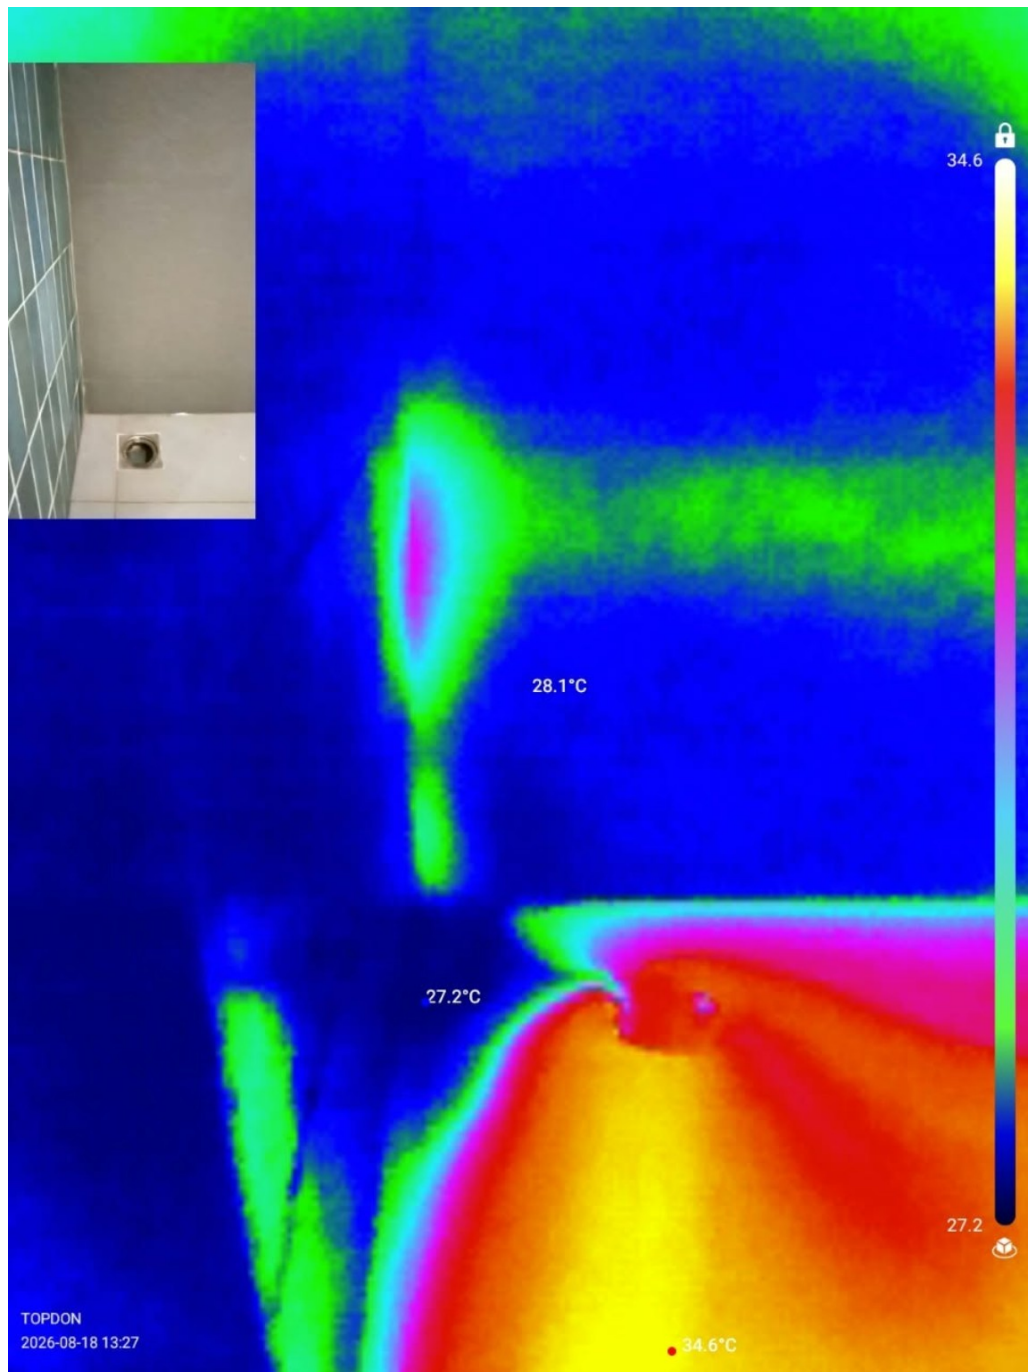
*Thermal anomaly used as part of the process to narrow the suspected leakage pathway.*
